# **FINAL REPORT**

## **EIGHTH FLOOR LOAD STUDY**

**UNITED STATES FEDERAL BUILDING  
517 GOLD AVE. SW, ALBUQUERQUE, NEW MEXICO**

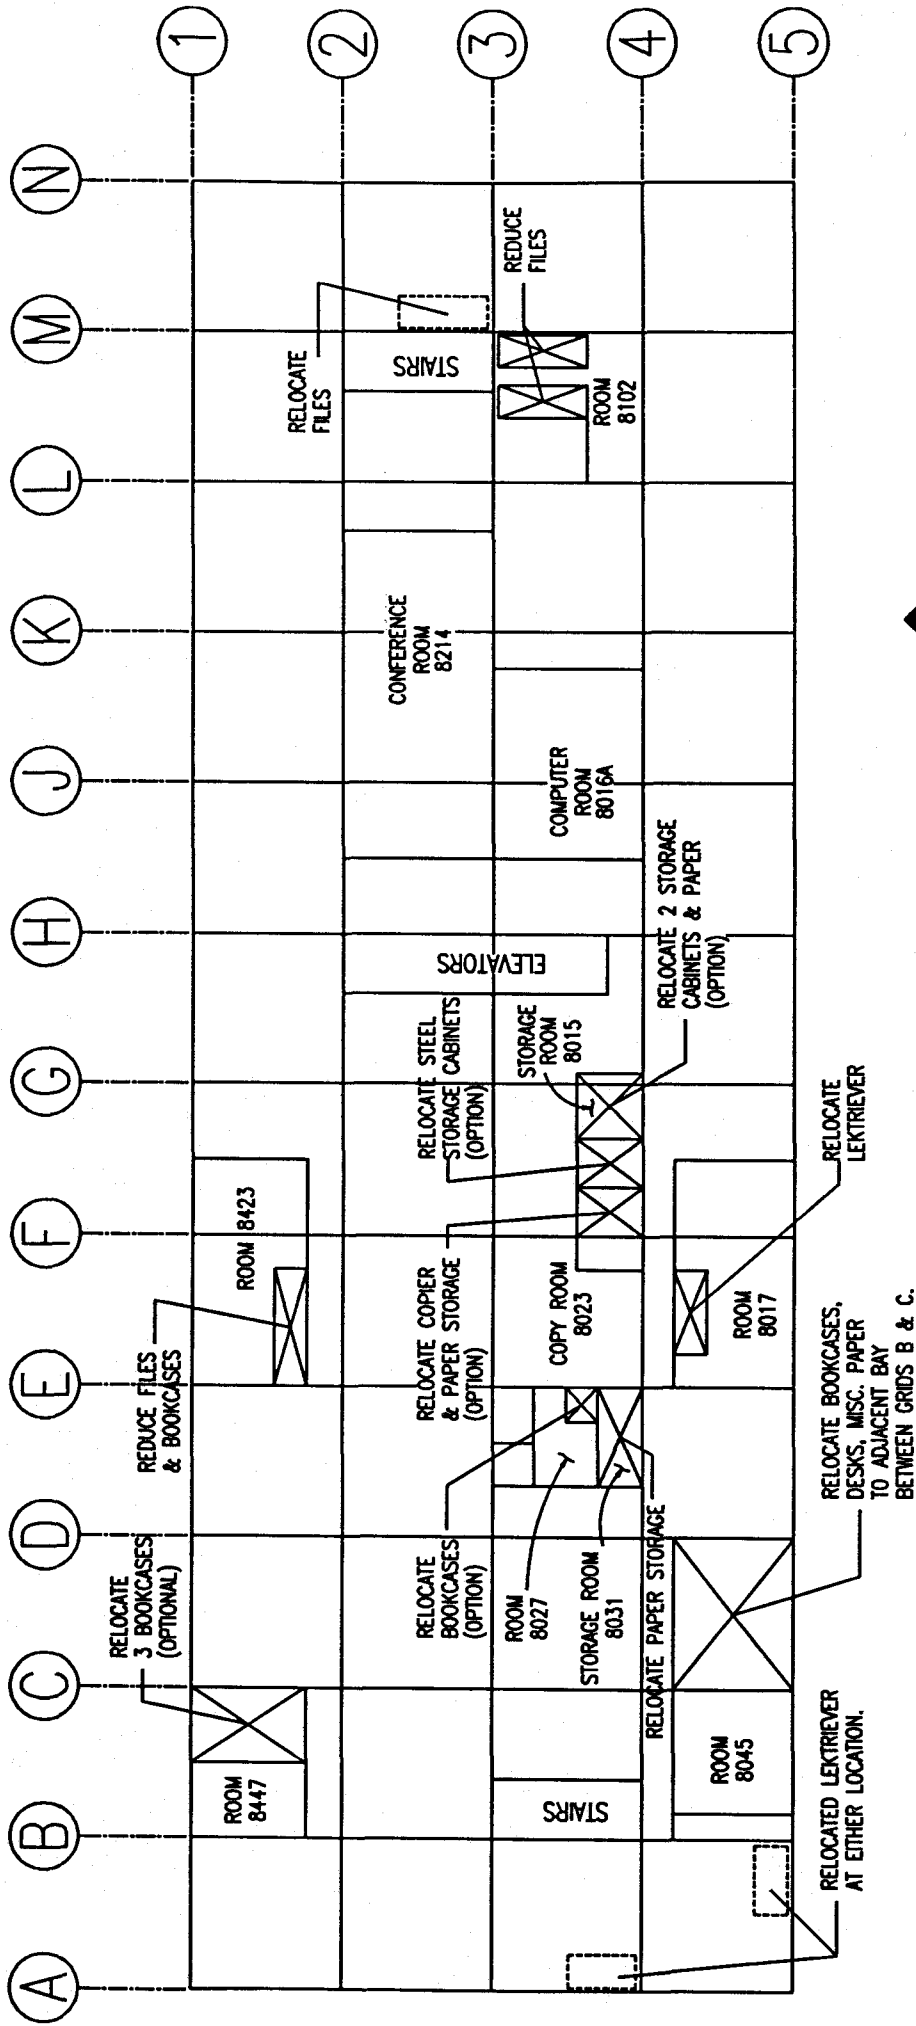
FIGURE 2

At bays where live load reduction is recommended, the existing live loads are indicated inside a circle. This condition occurs at six bays. The existing live loads at these bays are greater than the allowable live loads by more than 10 to 12 psf. Areas where high live load should be reduced, and possible options for relocation of contents are shown on Figure 2. The following are initial recommendations at each bay where contents should be moved to reduce the existing live loads so they do not exceed the allowable live loads by more than 10 psf. Other options for relocation of contents are possible, and will need to be coordinated with the Building Manager and the Corps of Engineers based on their operational needs.

The Lektriever at room 8017 is the main reason for the overload at this bay. The live load at this bay should be reduced by approximately 5,500 lbs. This reduction could be accomplished by relocating the Lektriever to either of the locations near the west stair as shown on Figure 2.
